Ride-Rite™ Warranty Evaluation Guide

WARRANTY GUIDE

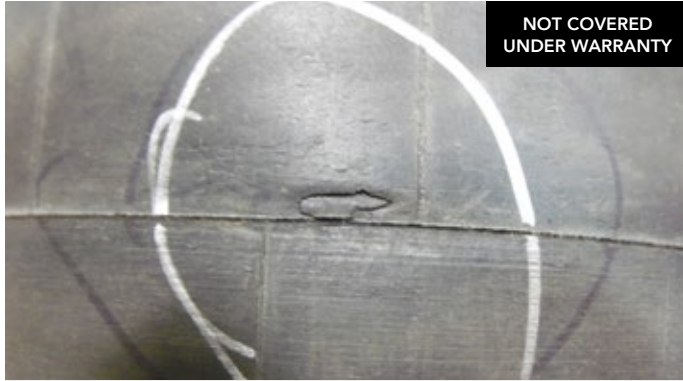
Puncture

Rubber bellows close-up

- Irregular shaped cut in the bellows

- Debris punctured the bellows
- Mounted too close to a sharp object

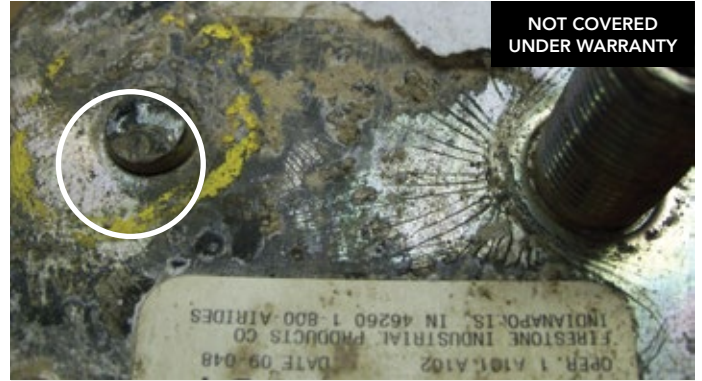
Bent Alignment Pin

Convuluted shown

- One side of alignment pin is pushed down toward the bead plate
- Marring or semicircular gouge in the top of the alignment pin
- Pin pushed in

- Alignment pin was not installed into the alignment pin hole in the bracket
- Attachment hardware not tightened

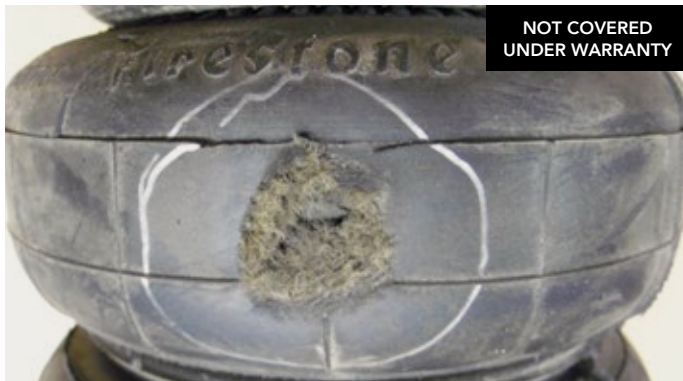
Abrasion

Convuluted shown

- Hole rubbed into side of bellows or in area that rolls over piston (sleeve style)

- Contacting a vehicle or other suspension component
- Inadequate air pressure
- Road debris
- Oversized tire contact
- Snow chain contact
- Inadequate tire to frame clearance

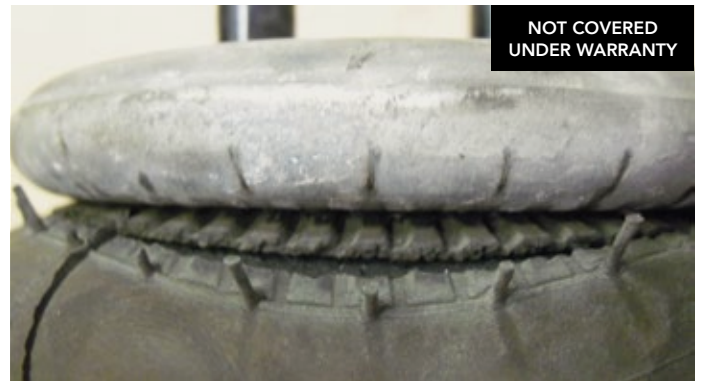
Circumferential Cuts

Convuluted shown

- Bellows cut or separated around the perimeter of bead plate or piston

- Too much air pressure, over extended for long periods of time
- Bottoming out
- Air spring overextended
- Normal wear and tear over years of usage

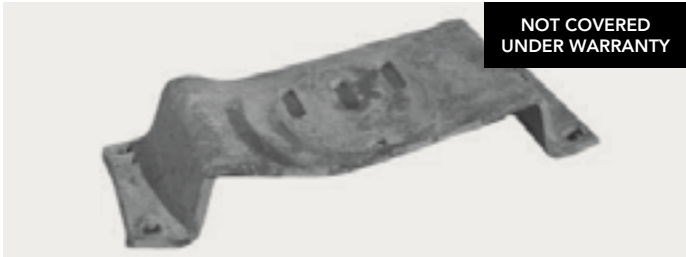
Bent or Broken Brackets & Bolts

- Distorted shape
- Possible cracking or “tearing”

- Not enough air pressure in the system for the load
- Overloading the vehicle/air springs
- Bottoming out

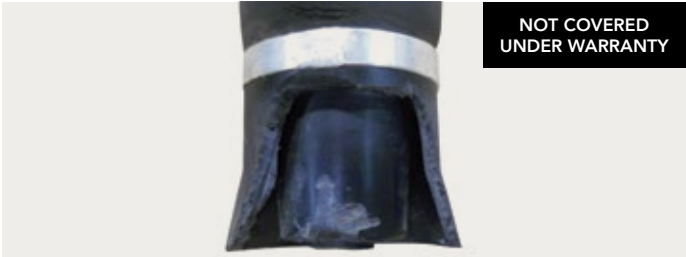
Broken Piston

- Cracked or broken piston

- Road debris
- Not enough pressure in the system for the load
- Overloading the vehicle/air springs
- Installed height of air spring too short
- Bottoming out

Bottom of tapered sleeve shown (Sport-Rite™ application).

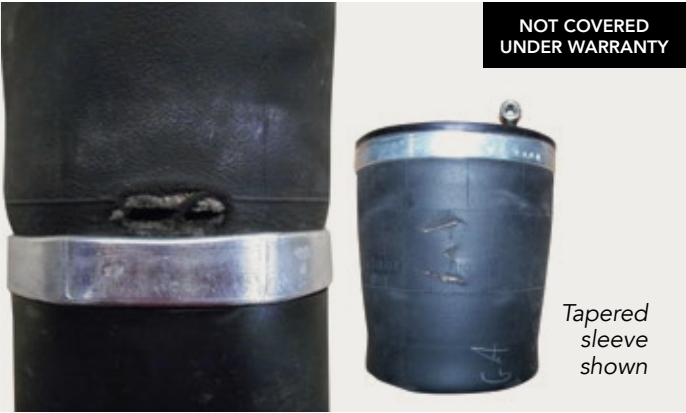
Bottoming Out

- Bent brackets or beadplates
- Broken girdle hoop (convoluted parts), caps or pistons (sleeve parts)
- Cuts near the bead plates, caps, or pistons
- Leaking around blind nuts

- Installation height is too low, resulting in air spring too short
- Not maintaining the minimum air pressure
- Not enough air pressure for the load
- Overloading the vehicle/air springs

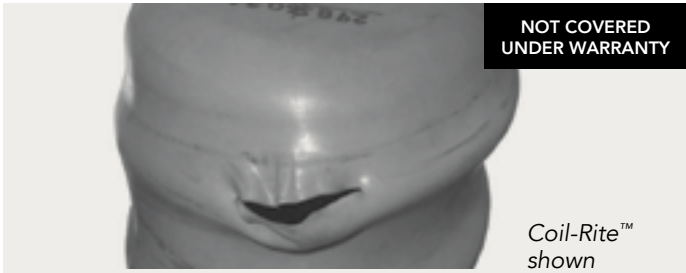
High Temperature / Over Inflation

- Tear in the side of the part, material seems thin or “stretched”

- Exposed to high temperature for long periods of time (too close to exhaust)
- Over inflation (see manual for max operating pressure)

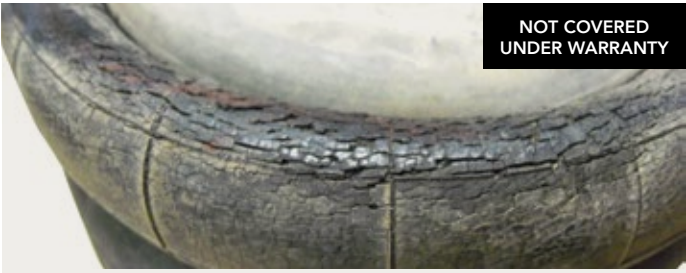
Cracked / Hard Bellows

- Cracking in bellows around bead plates and caps or where the sleeve rolls over the piston
- Hard to the touch, no longer flexible

- Exposed to high temperature for long periods of time
- Old air spring – Rubber ages and will wear out eventually; the air spring is not warrantable and needs to be replaced
- Normal appearance after product’s end of life

Convoluted shown

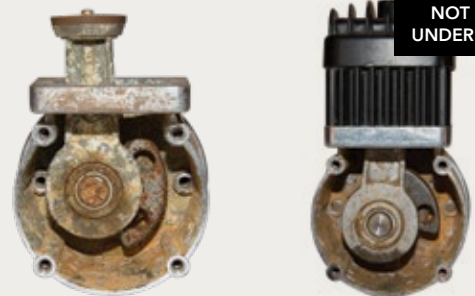
Crank and Rod

- Compressor will not start
- Compressor will not pump air

- Compressor was submerged
- Compressor inlet pulled in moisture from environment

- Replace compressor
- Snorkel air filter to a dry, dust free location (max. 6ft.)

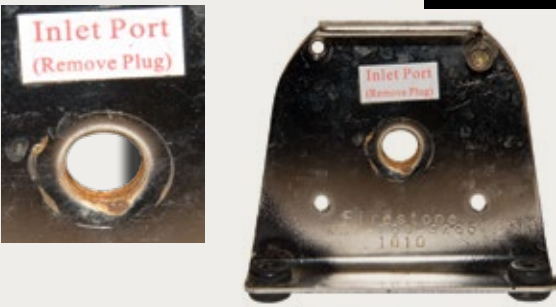
Inlet Plate

- Rust around threads of inlet port
- Compressor will not pump air
- Compressor runs at high current (blows fuses)

- Compressor was submerged
- Air filter assembly was not installed properly

- Replace compressor
- Snorkel air filter to a dry, dust free location (max 6ft)
